Release Note

FTP MP3 V00.73

Firmware name:	FTP MP3 V00.73		
Released:	19. Jul. 2010		
Package name:	abcl_ftmp3_XXXX_v0073_20100719		
Version overview:	Type	File name	Version Date
	Firmware	abclw.rom	VA0.33_20100603
	WEB UI	abclapp.cob	V01.13_20100602
	FW Ext. 1	sg.bin	V08.10_20100719
	FW Ext. 2	fs.bin	VA2.05_20100113
	FW Ext. 3	bclio.bin	V01.14_20100421
	Bootloader	exfull.spb	V99.16_20100708
	ES Module	esnd.rom	V00.05_20091230

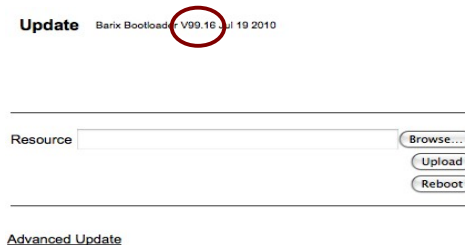
- To be able to upgrade to the new bootlader, a serial update should be performed. Loading only the **compound.bin** using the web update will **NOT** change the bootlader. If serial update is not possible, the bootlader may be upgraded by uploading the **unifull.spb** file to WEB9 web page using the advanced web update. In this case the new bootlader will be updated during the next boot. However, this will destroy the BCL application, so it is advised to do the bootlader update **BEFORE** uploading the **compound.bin** file. If you have already updated the **compound.bin** file, you need to reflash it again after the bootlader update. After that boot the device, and go to the web update page again. You should see the new version there:

¹ To be able to upgrade to the new bootlader, a serial update should be performed. Loading only the compound.bin using the web update will not change the bootloader. If serial uppdate is not possible, the bootloader may be ubgraded by uploading
